CMS Interim Deliverables,
Agencies Comments and FMC's
Responses to Comments on Tree
Preservation Measures Technical
Memorandum, Soil
Tilling/Blending Pilot Study
Report, and 2009 Arsenic
Phytoremediation Pilot Study
Results

Figure 1-1	Corrective Measures Study Area
Figure 4-1	Methods for Determining Protected Root Zone
Figure 5-1	Conceptual Illustration of the Development of a Planted Nursery Stock Tree

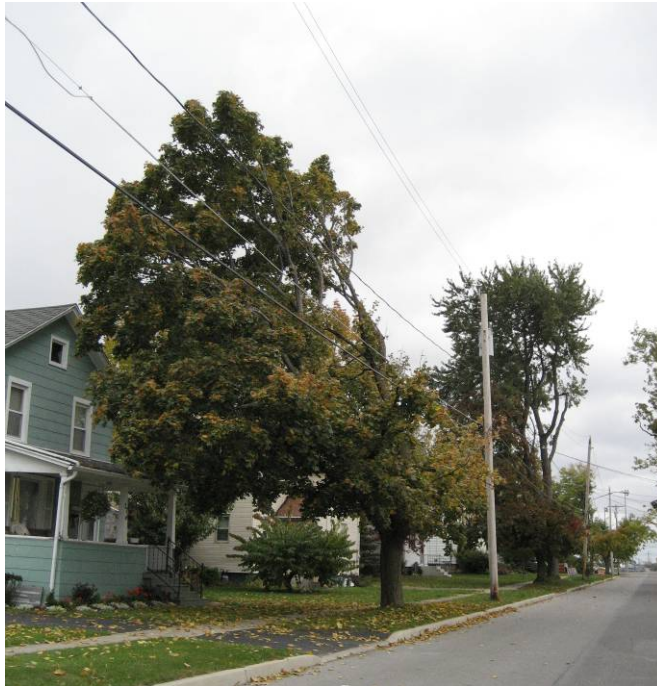
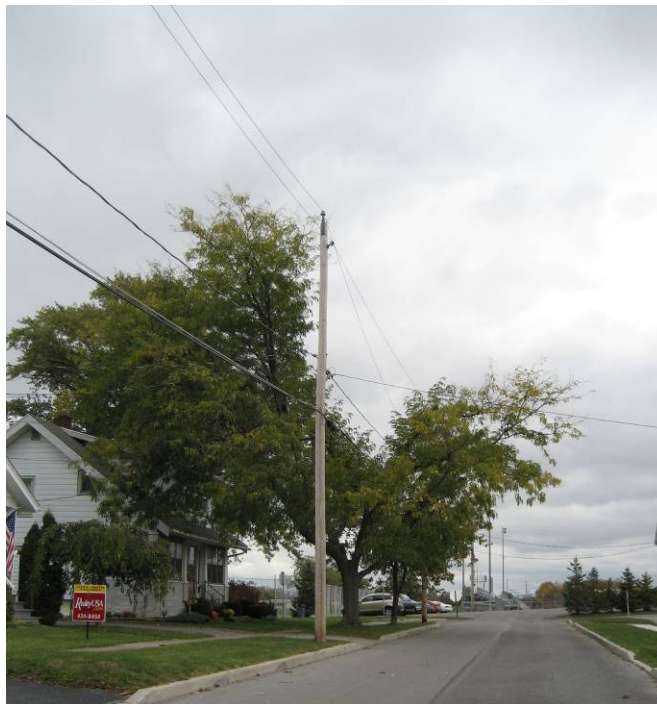
Photographs 1 and 2. Significant pruning of mature trees within existing right-of-ways and proximate to existing utility lines

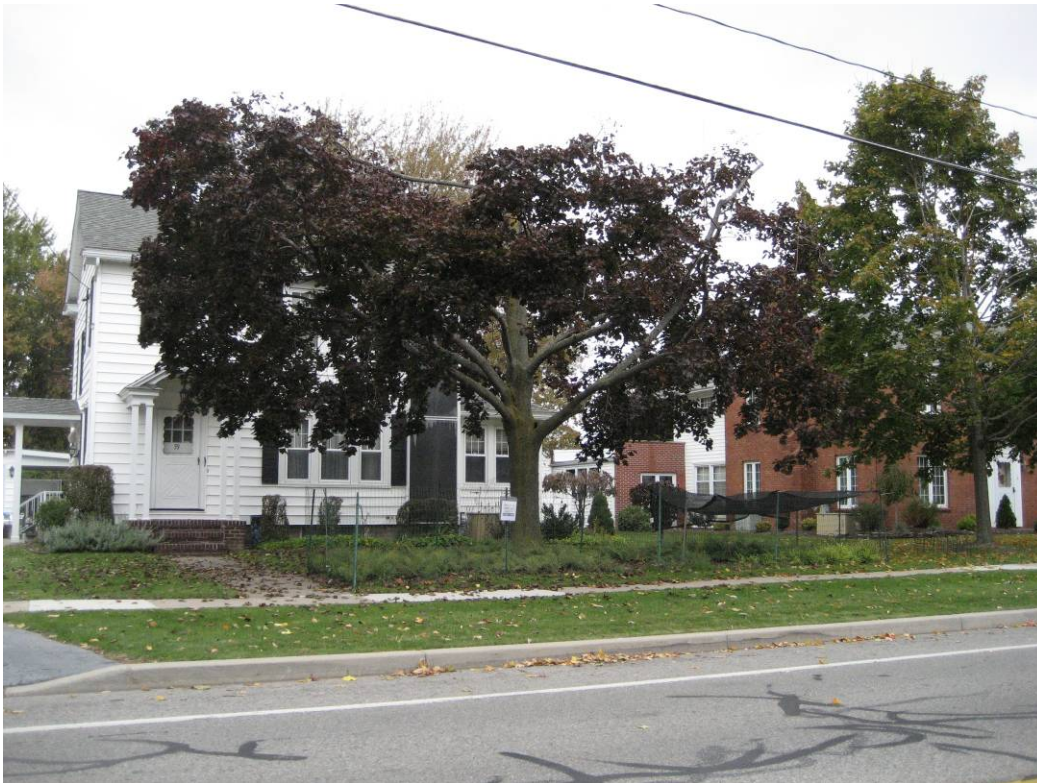
Photograph 3. Significant pruning of mature trees within existing yards of single family residences

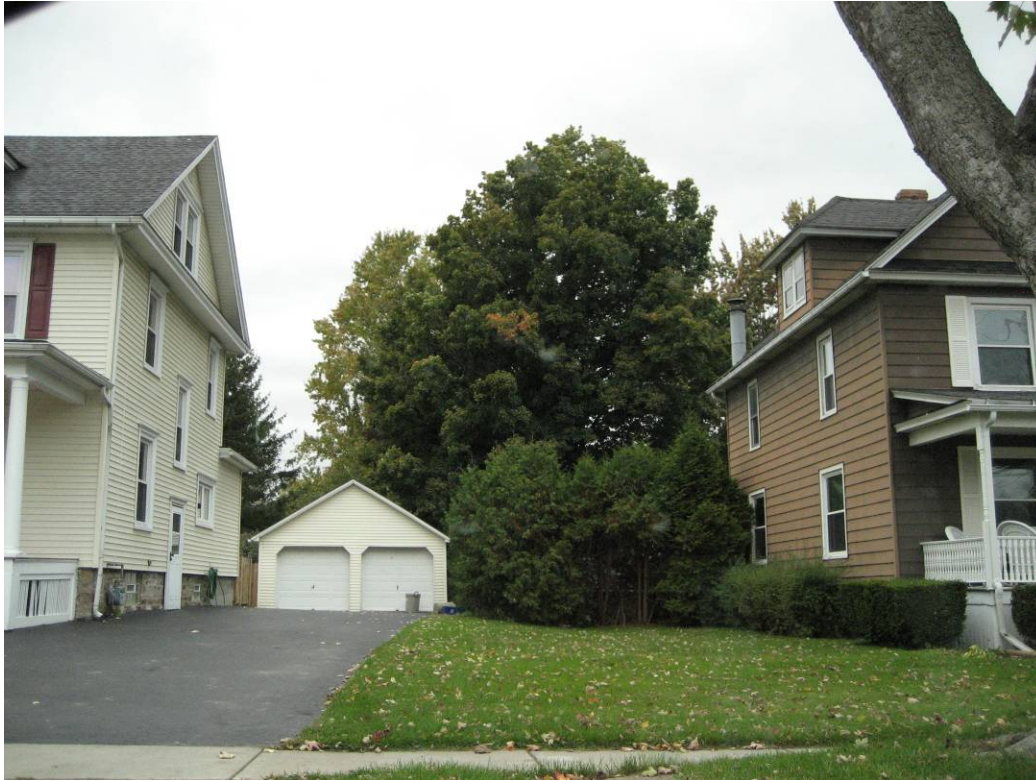
Photograph 4. Significant canopy cover from healthy mature trees in the yards of single family residences

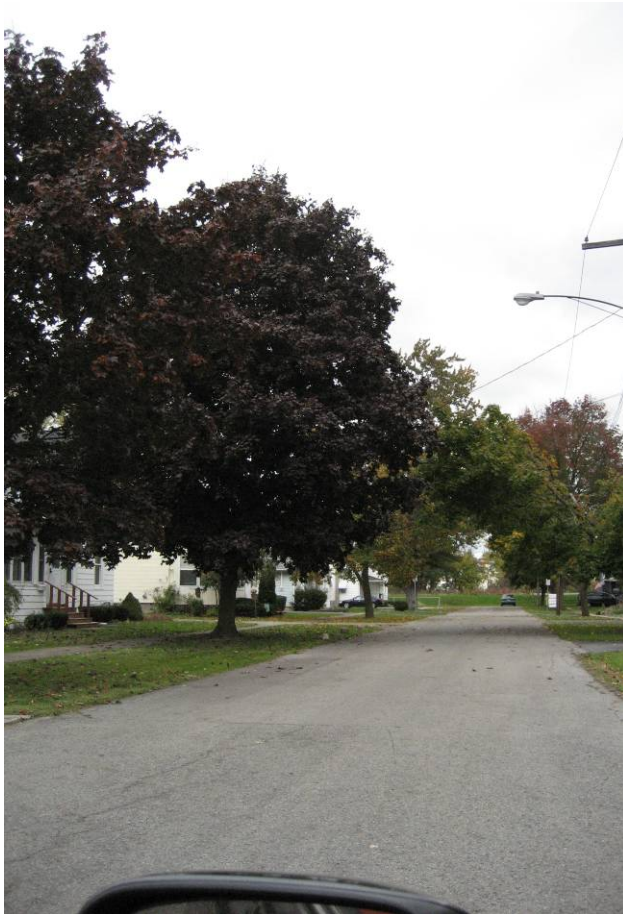
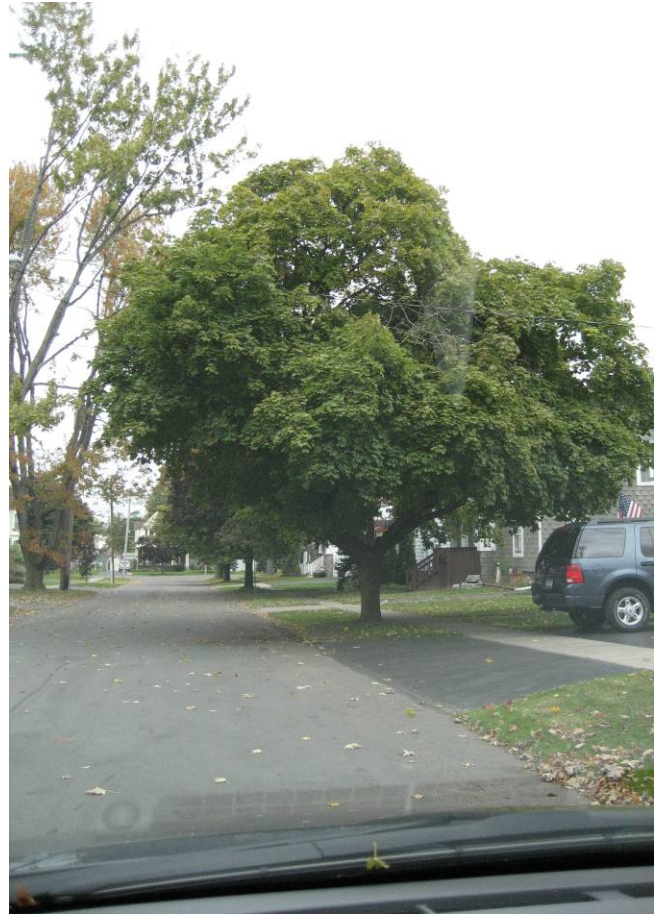
Photographs 5 and 6. Healthy trees within an active right-of-way

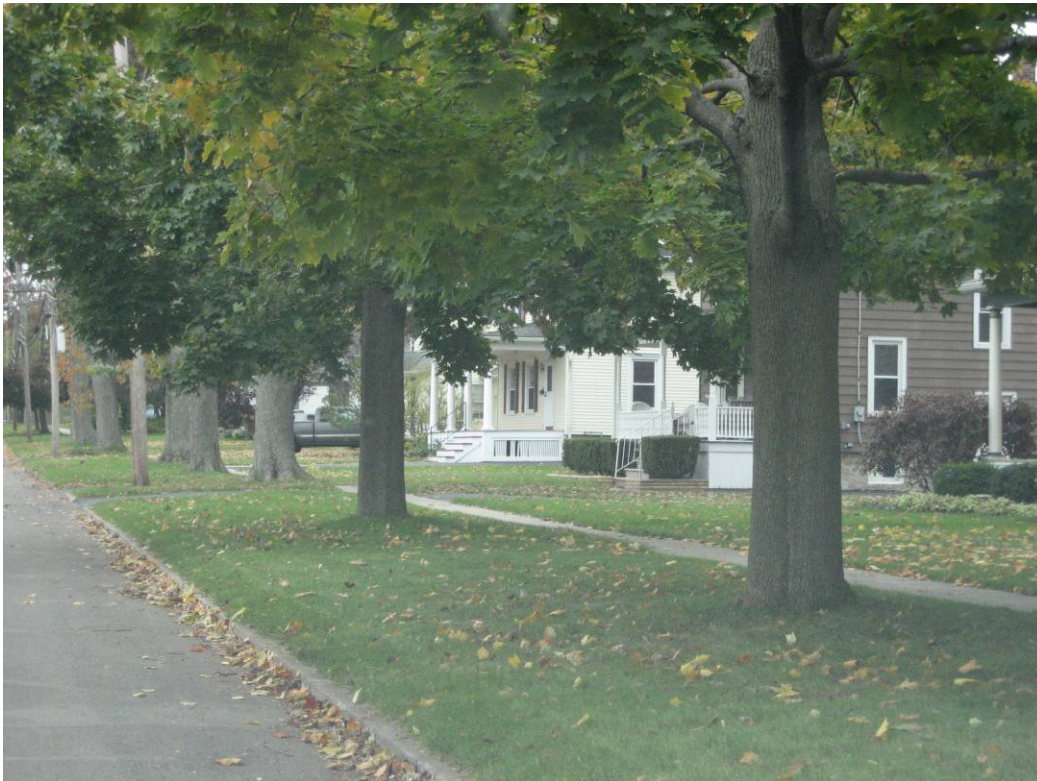
Photograph 7. Significant tree canopy coverage within active right-of-ways
